Final Report:

## **Survey and Investigation of Buildings Damaged by Category III Hurricanes in FY 2016-17 – Hurricane Matthew 2016**

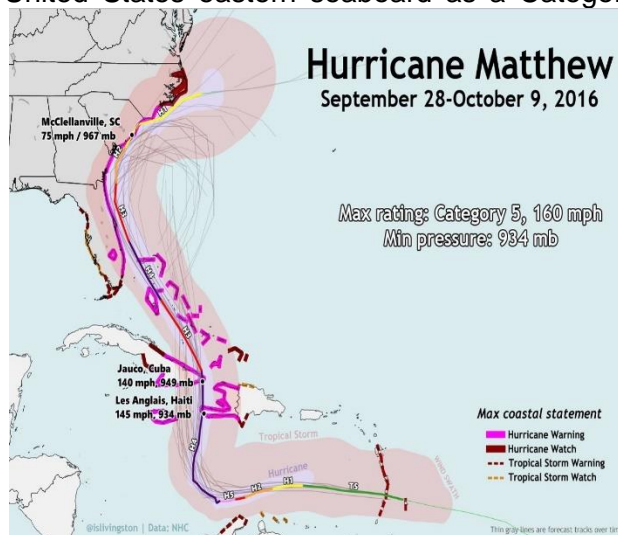
Figure 1: Hurricane Matthew track (graphic created by Ian Livingston, [Washington Post Capital Weather Gang](#)).

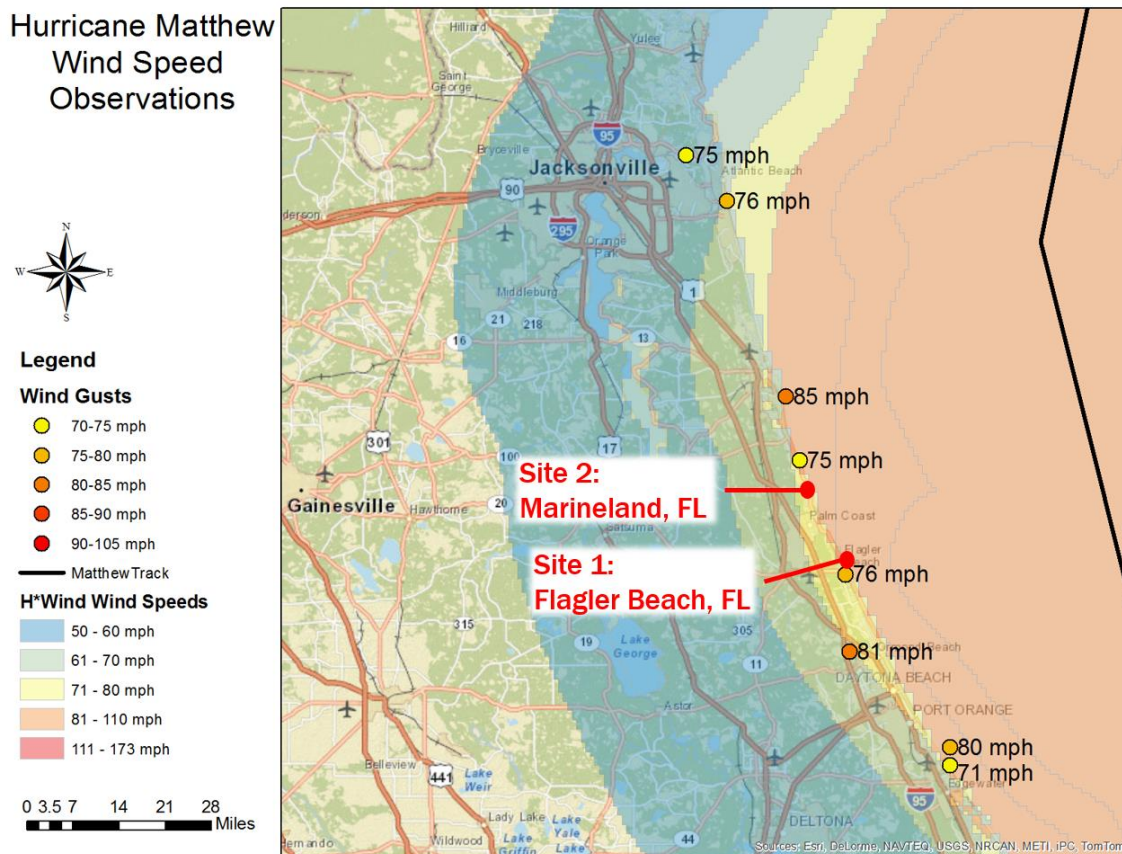
Figure 2: Estimated and observed 3-second gust wind speeds at 10 m height along the NE coast of Florida. Colored dots and labels represent wind speed observations from weather observation towers. Colored contours are provided by H\*Wind (Powell et al. 1998).

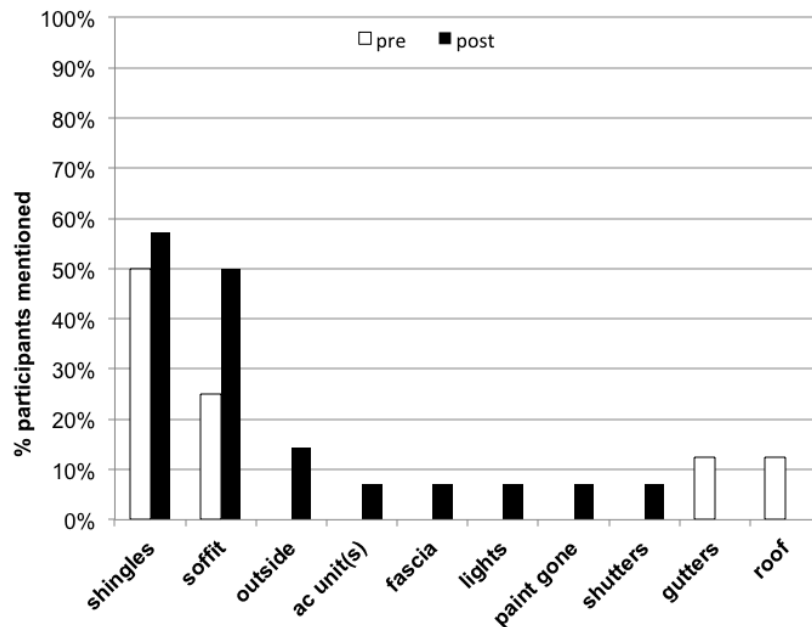
Figure 4: Types of exterior damage mentioned for pre- versus post-2001 FBC construction

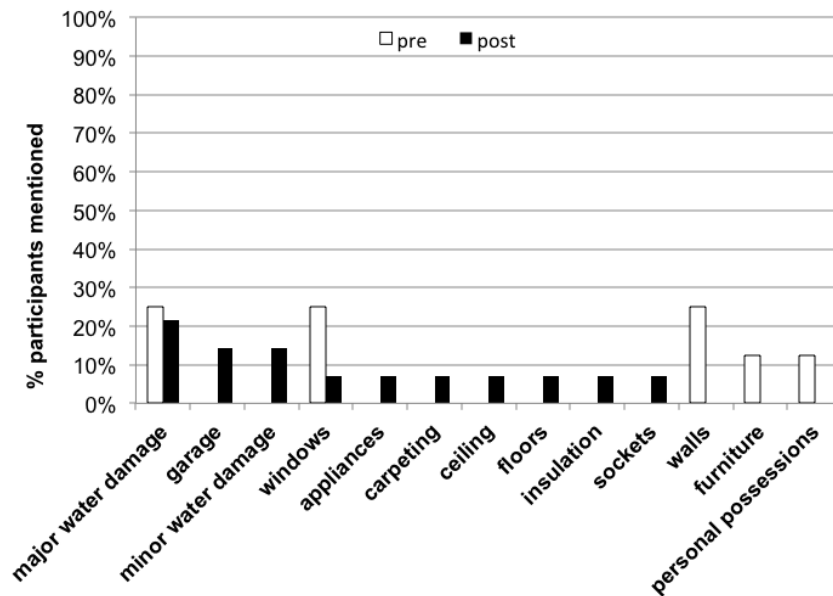
Figure 5: Types of interior damage mentioned for pre- versus post-2001 FBC construction

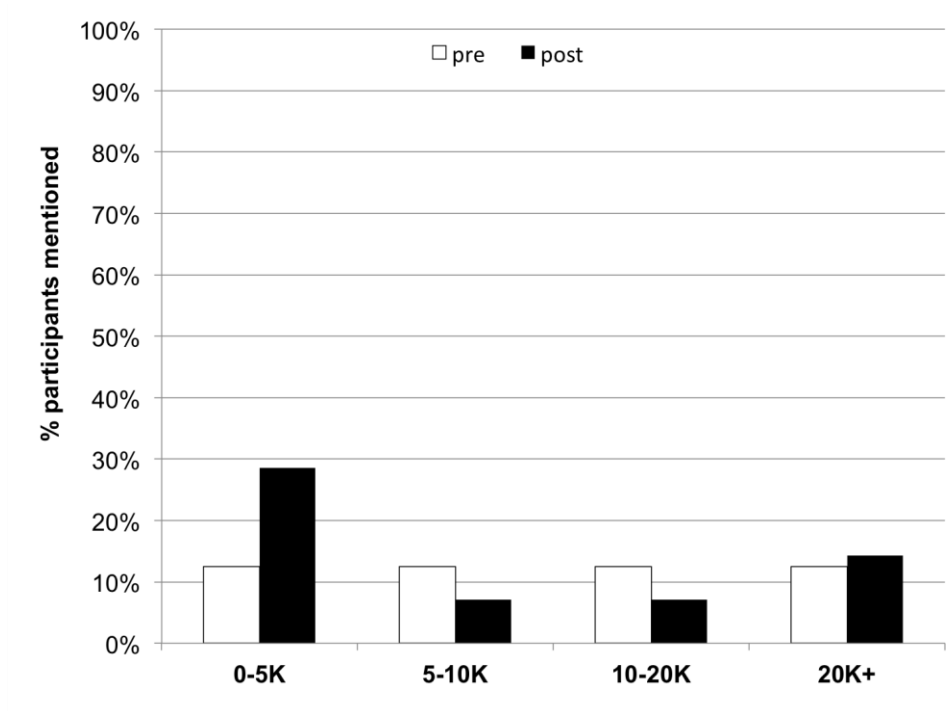
Figure 6: Reported damage estimates for pre- versus post-2001 FBC construction.

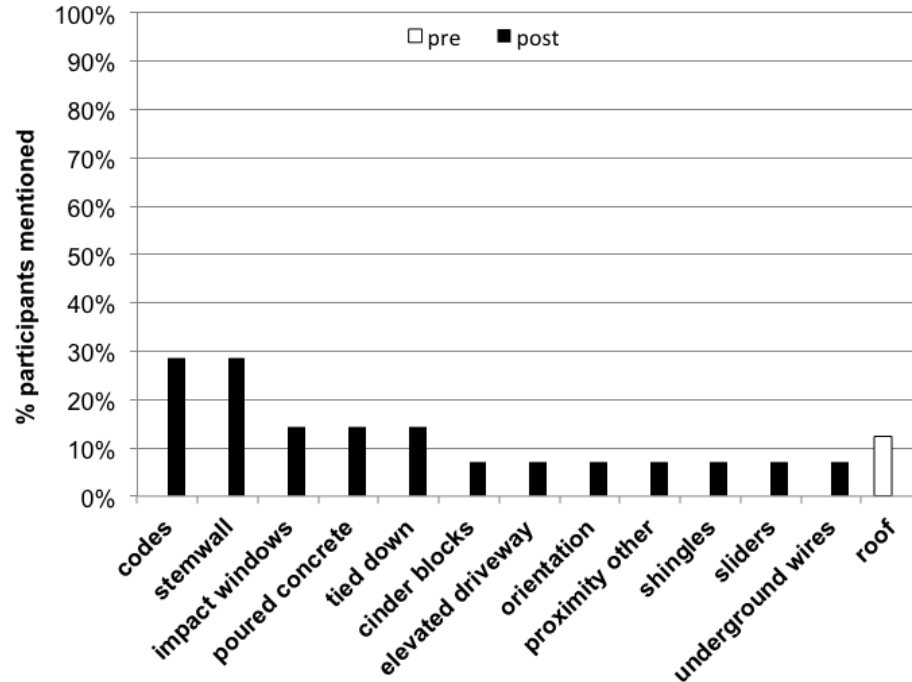
Figure 7: Features that prevented damage for pre- versus post-2001 FBC construction

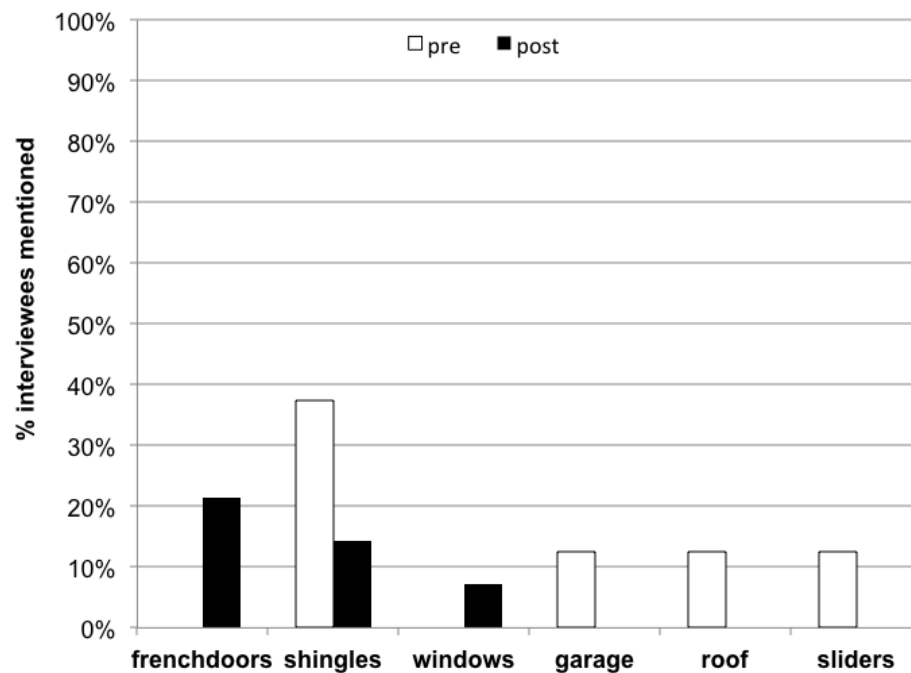
Figure 8: Features that failed for pre- versus post-2001 FBC construction

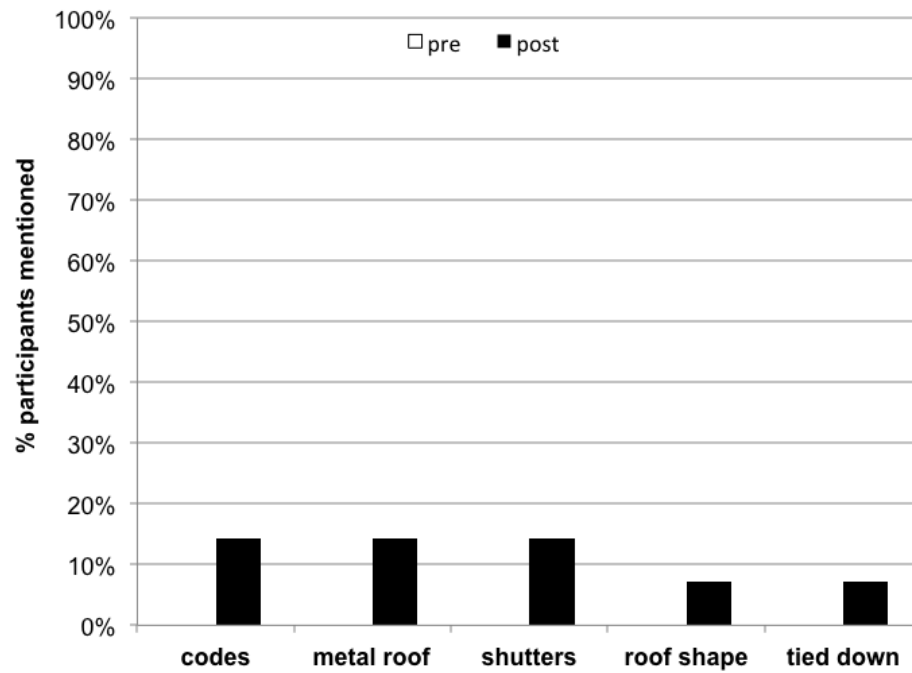
Figure 9: Features likely to protect during 120 mph hurricane (pre- vs. post-2001 FBC construction)

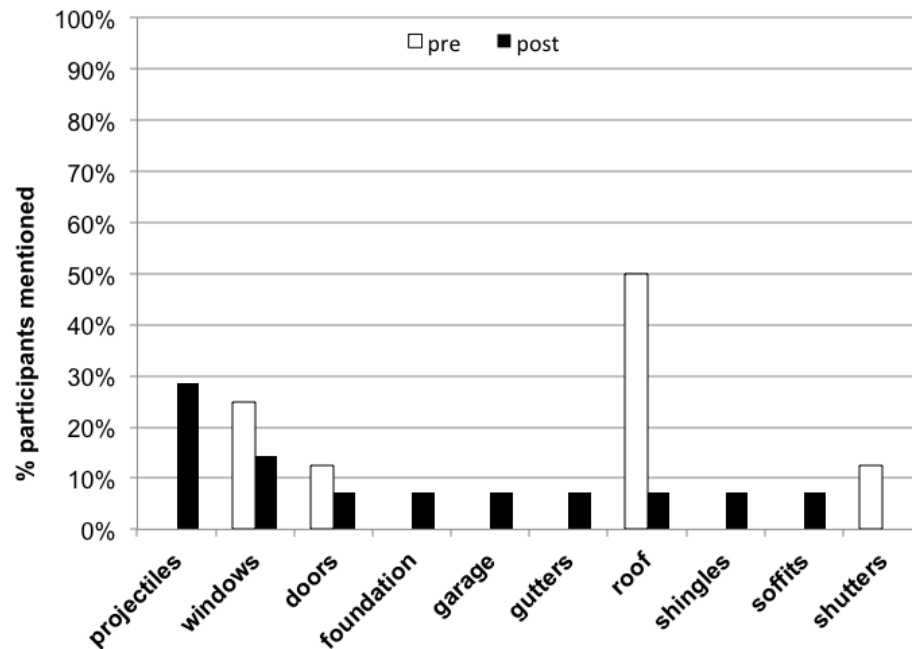
Figure 10: Features likely to fail during 120 mph hurricane (pre- vs. post-2001 FBC construction)

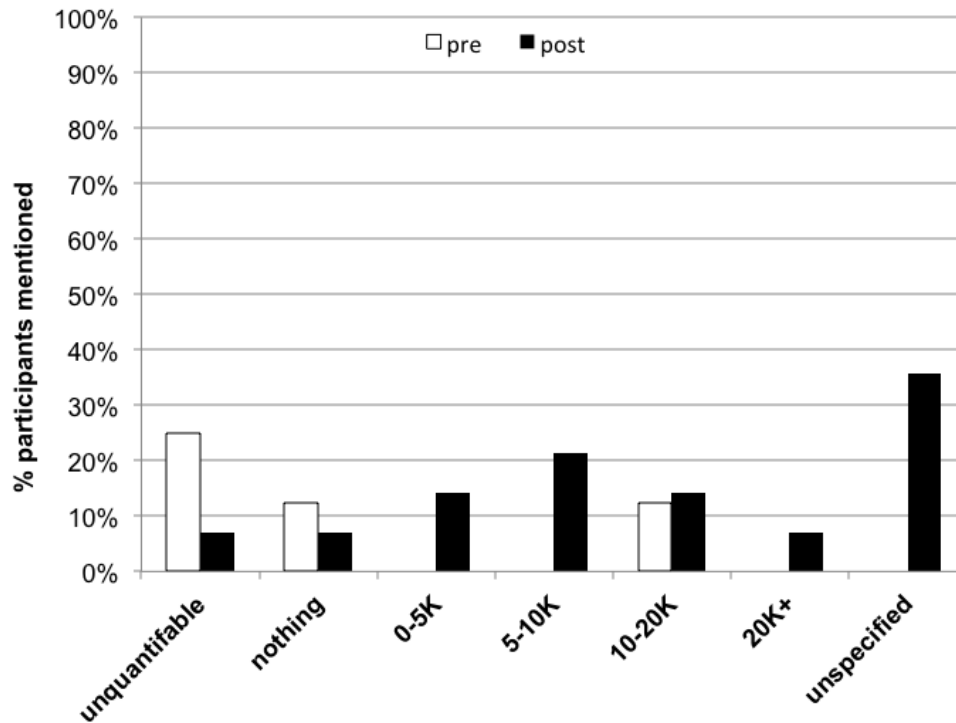
Figure 11: Reported willingness to pay to avoid damage from 120 mph winds (pre- versus post-2001 FBC construction)

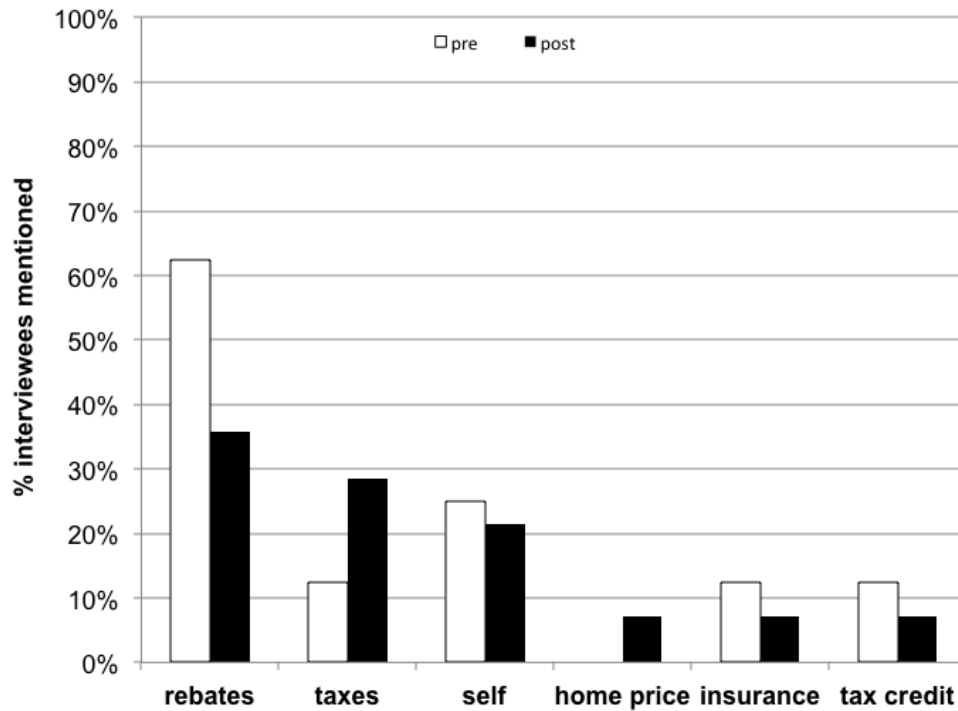
Figure 12: Mentioned strategies for paying to avoid damages (pre- versus post-2001 FBC construction)

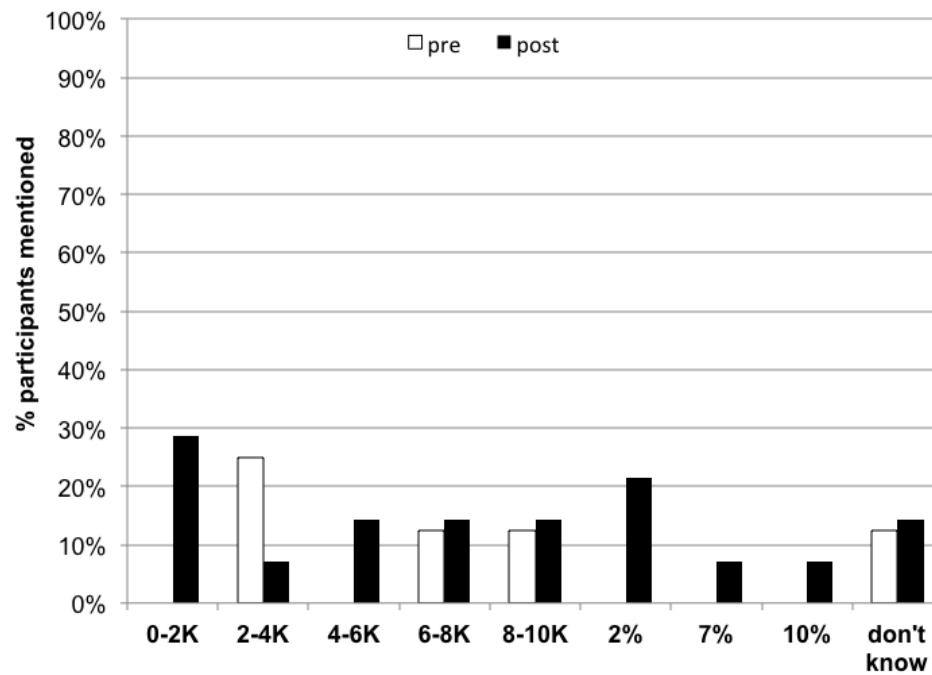
Figure 14: Deductible for pre- versus post-2001 FBC construction

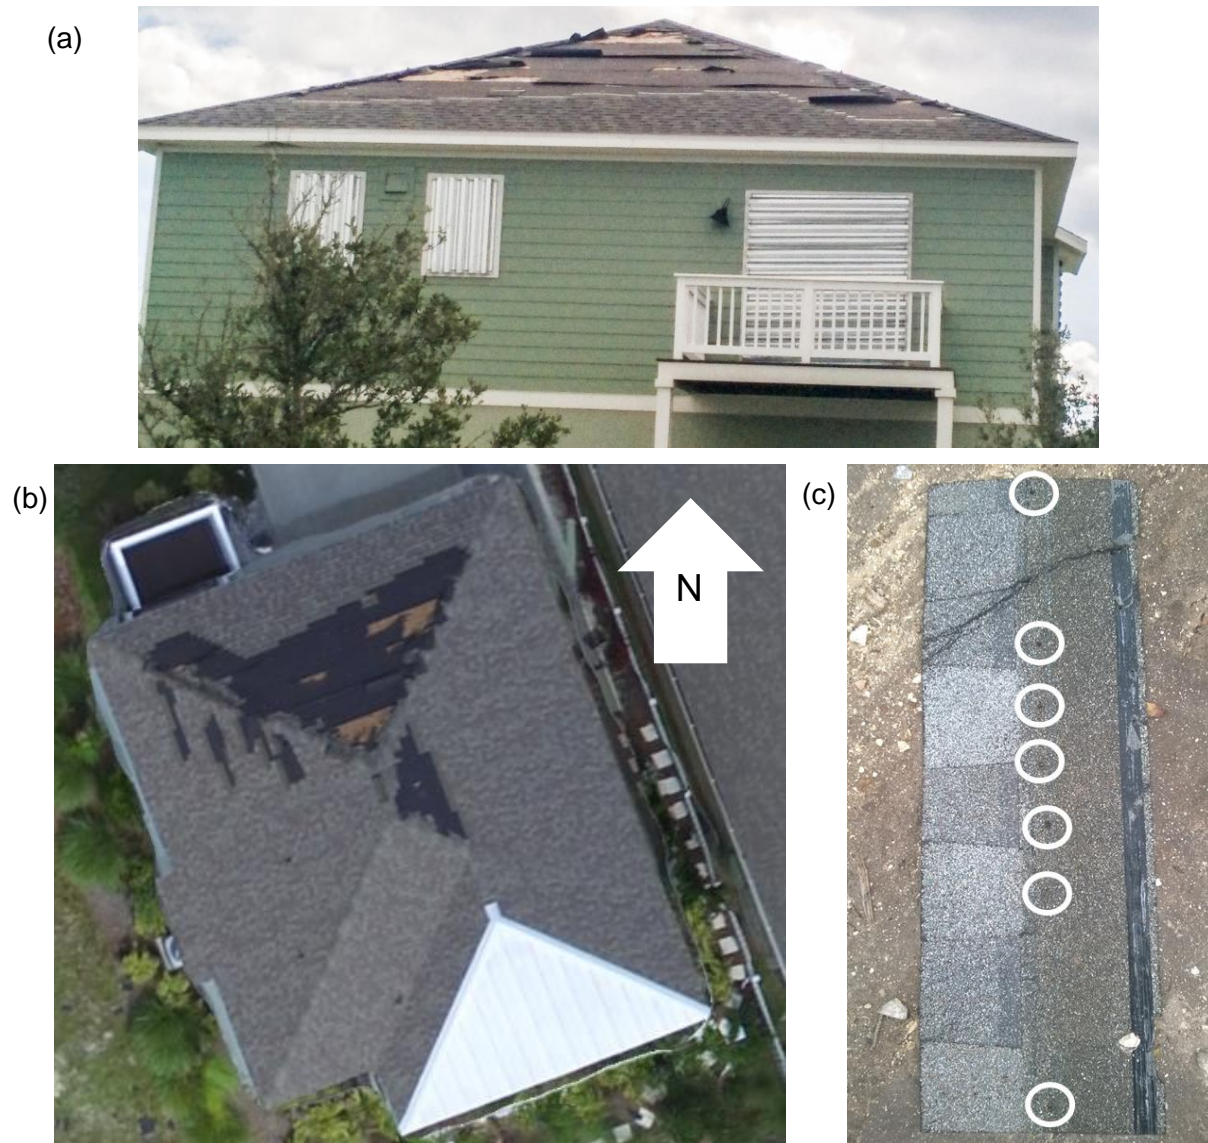
Figure 15: Approximately 20% of the laminated shingles removed from a two-story home at 30 Sandy Beach Way in the Marineland site, viewed from the ground (a) and a UAV (b). One of the failed shingles is shown in (c) with seven holes where fasteners were installed.

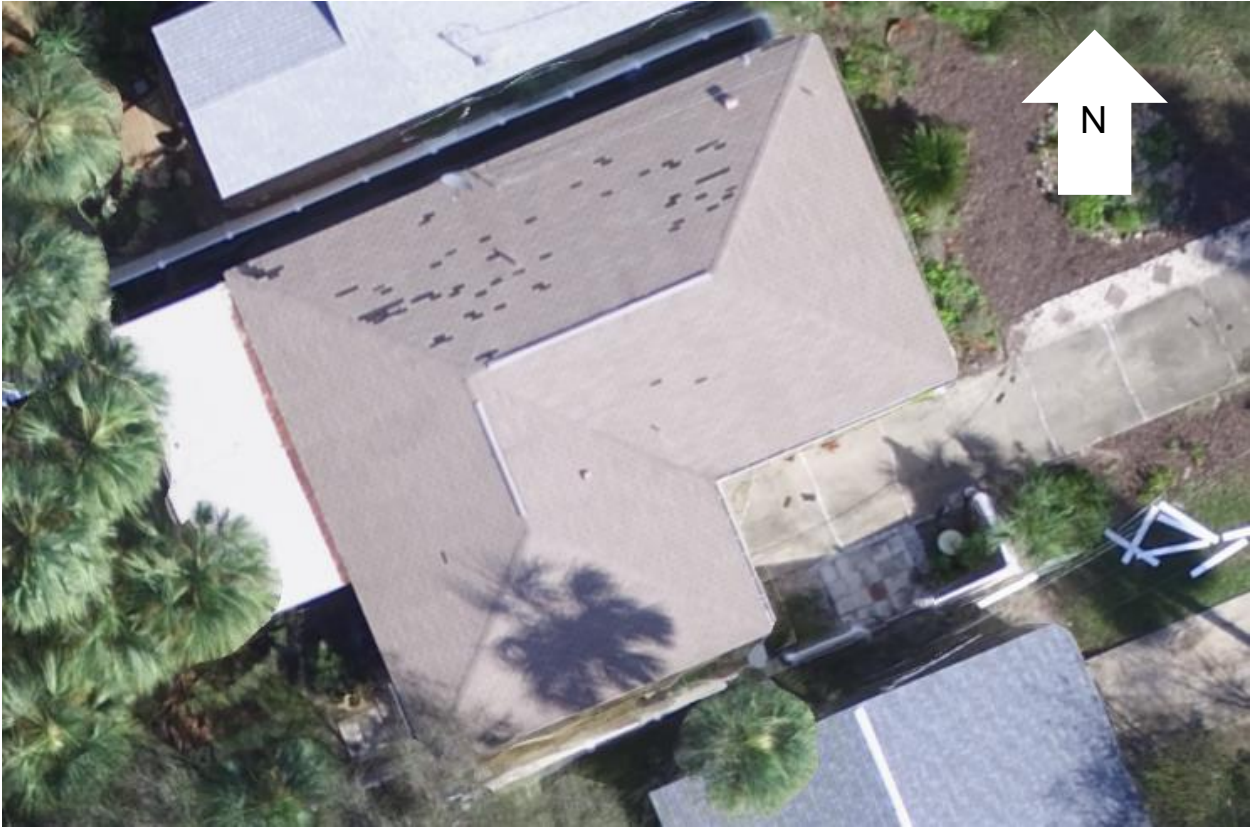
Figure 16: Scattered shingle damage to a one-story home at 1416 S Daytona Ave.

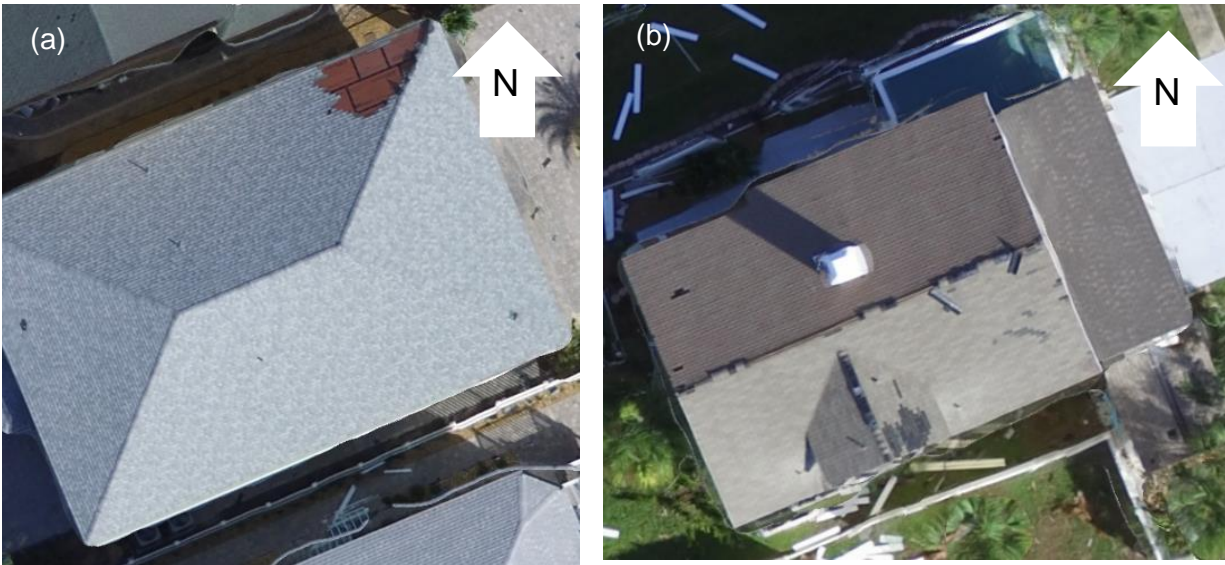
Figure 17: Shingle failure in a corner of a two-story home along Ocean Shore Blvd built in 2015 (a), and along the ridge of a 1995 home in Flagler Beach (b).

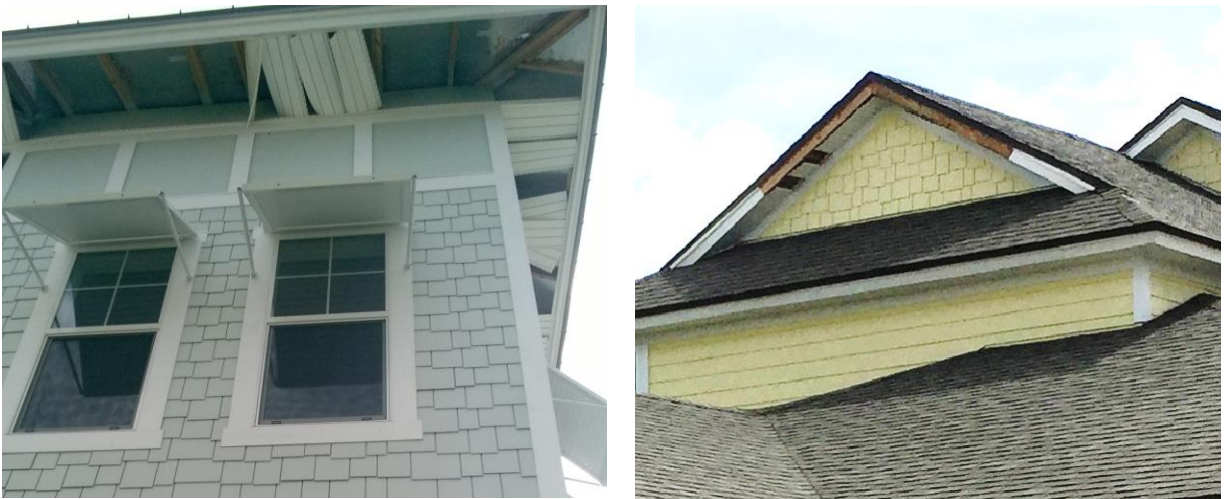
Figure 18: Soffit and flashing failure observed in several homes built after 2015.

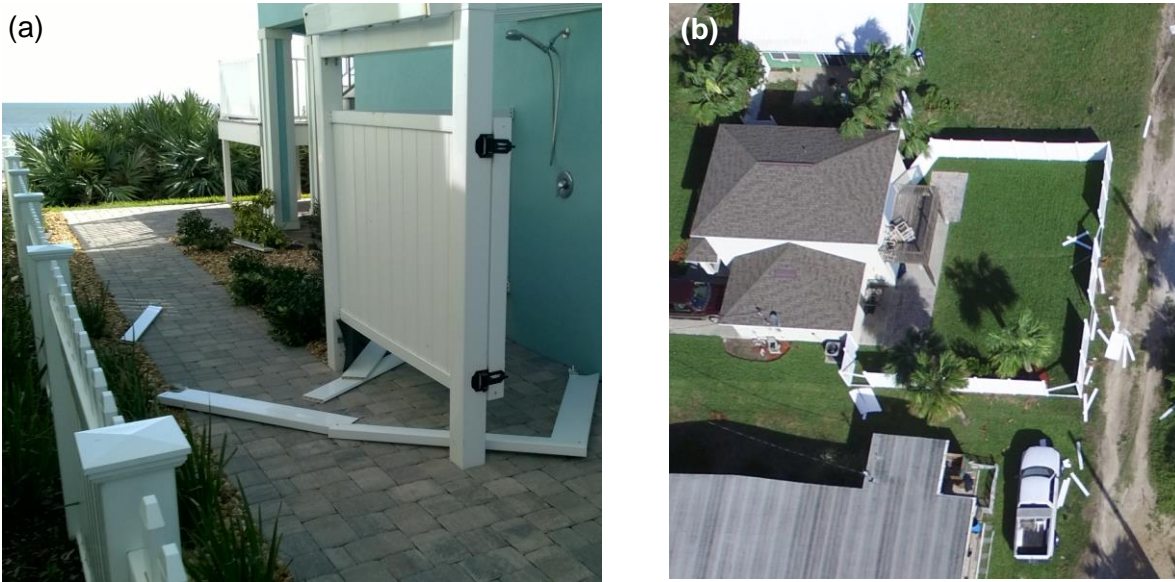
Figure 19: Failed vinyl fence slats at a home on Ocean Shore Blvd (a) and an aerial view of damaged vinyl fencing at a home along S. Central Ave (b).

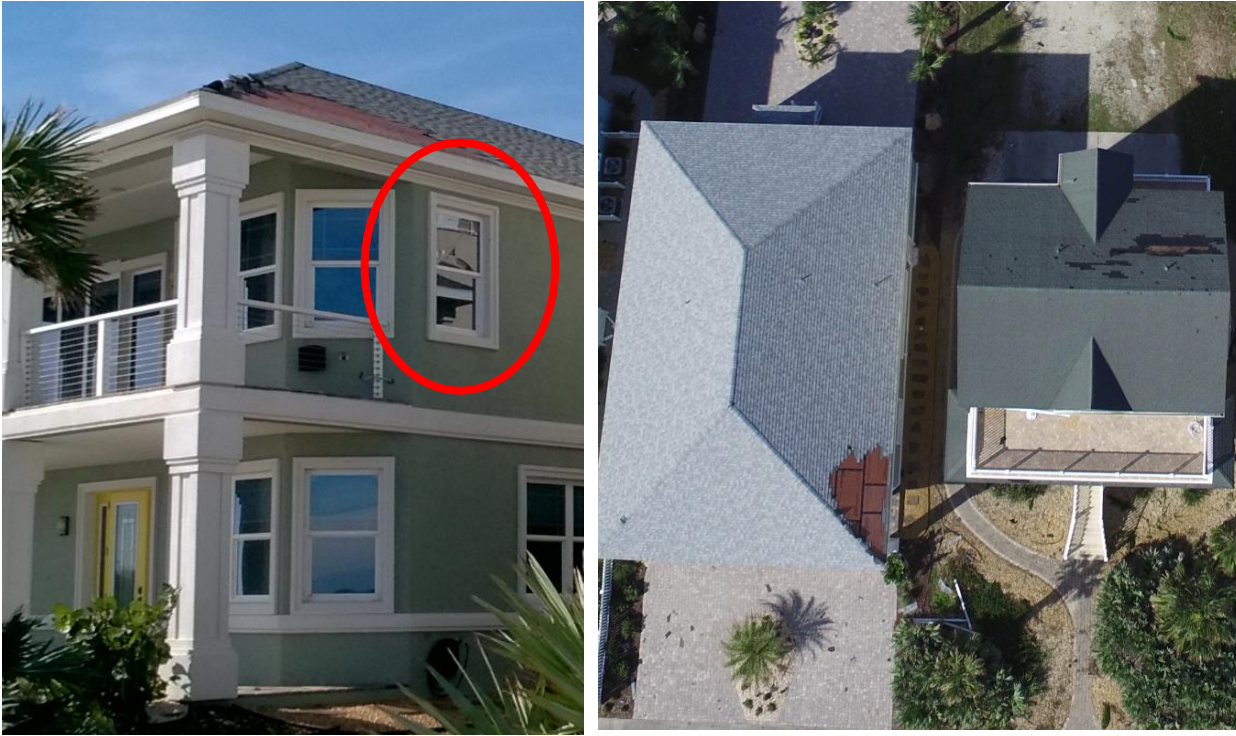
Figure 20: Ground view of broken window at 1424 S Ocean Shore Blvd (a) and aerial view of home with broken window and adjacent home which lost roof shingles (b).

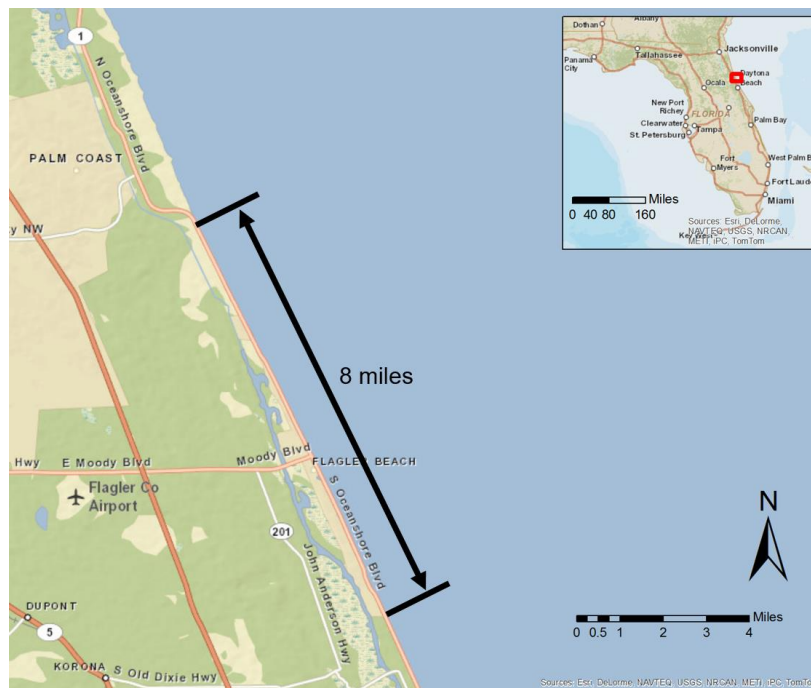
Figure 21: Coverage of aerial photographs provided by the Flagler County Emergency Management Division.

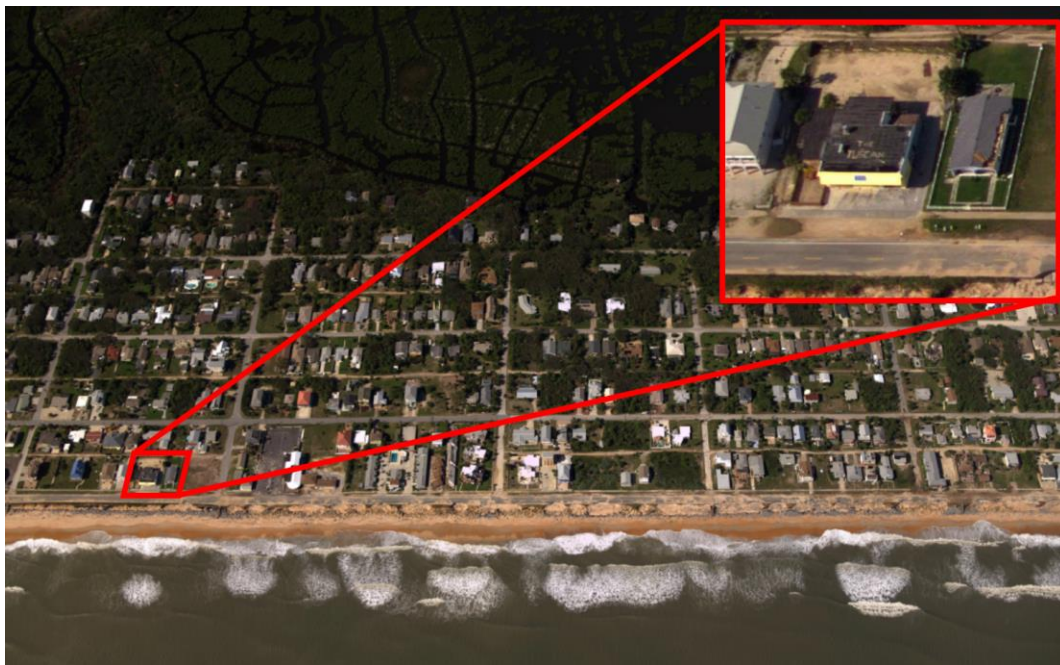
Figure 22: Photo “2016obP28253668.jpg” from a database of aerial photographs provided by the Flagler County DEM, with inset showing zoomed in view of roof sheathing and shingle damage to a multi-family home (far right of inset) at 1908 S Ocean Shore Blvd. Damage ratios for roof cover and roof sheathing were estimated to be 15%.

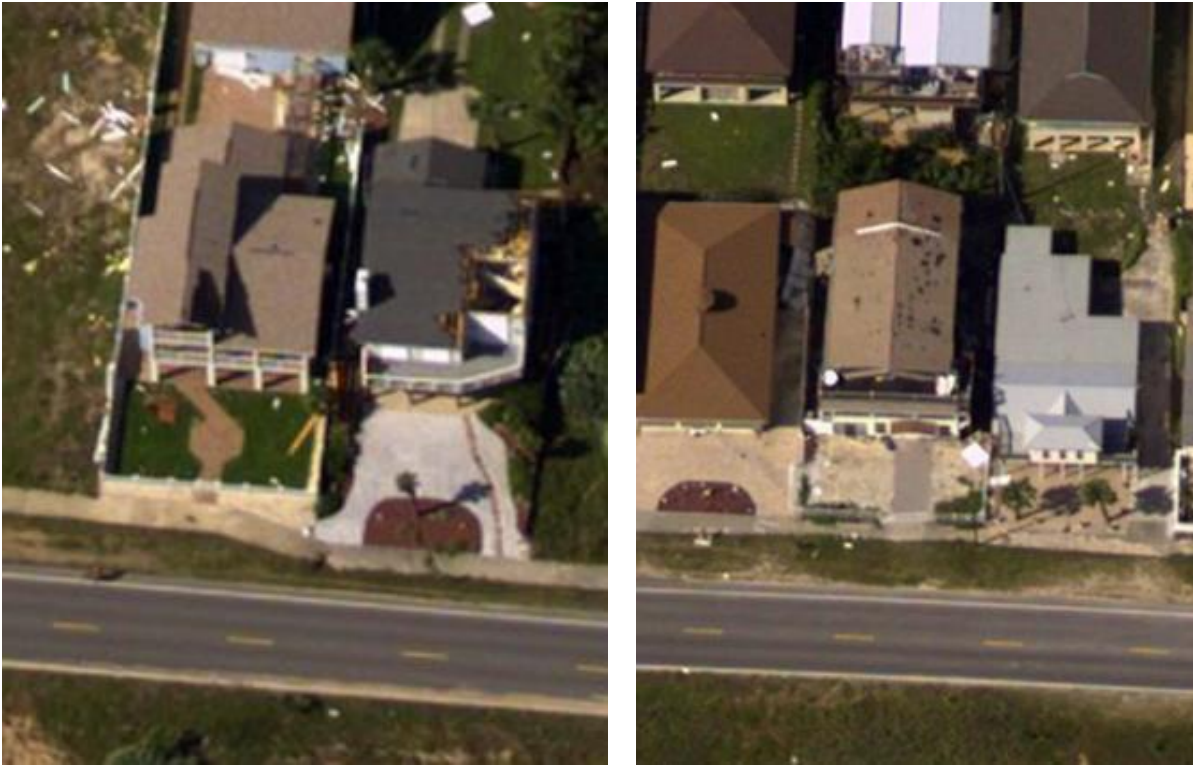
Figure 23: Examples of roof structure damage (left) and roof cover damage (right) visible in the aerial photographs provided by FCDEM.

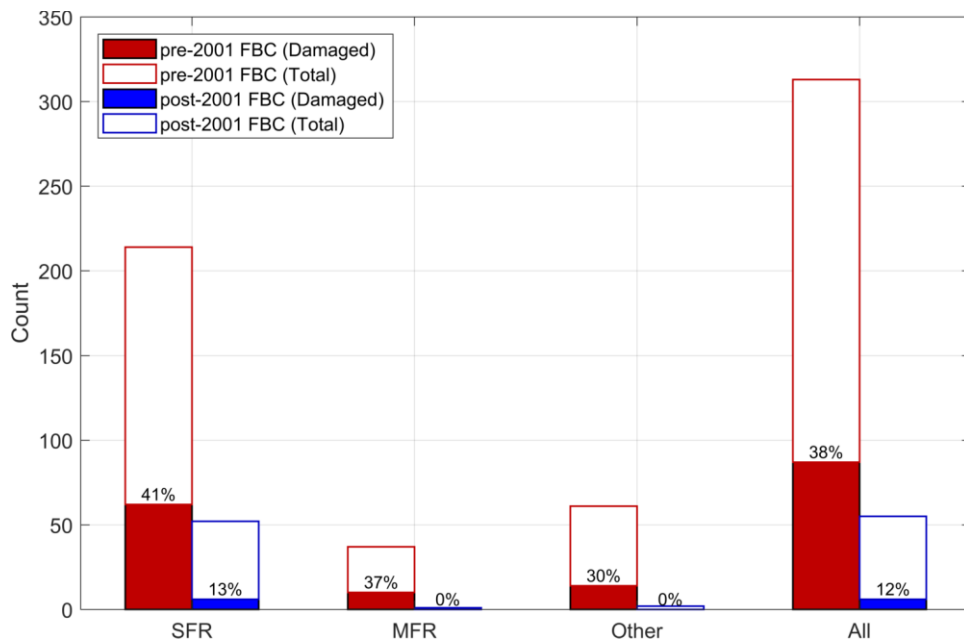
Figure 24: Number of buildings with observable damage by building type and year built. SFR = single family residence, MFR = multi-family residence, and Other = motels, restaurants and other buildings.

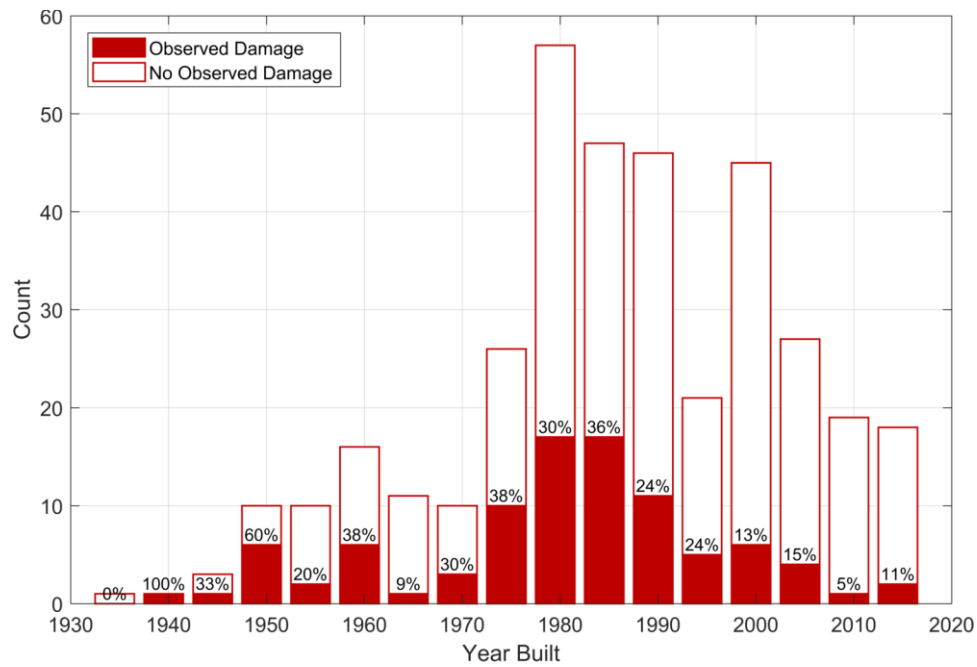
Figure 25: Number of damaged and undamaged buildings in five year bins.

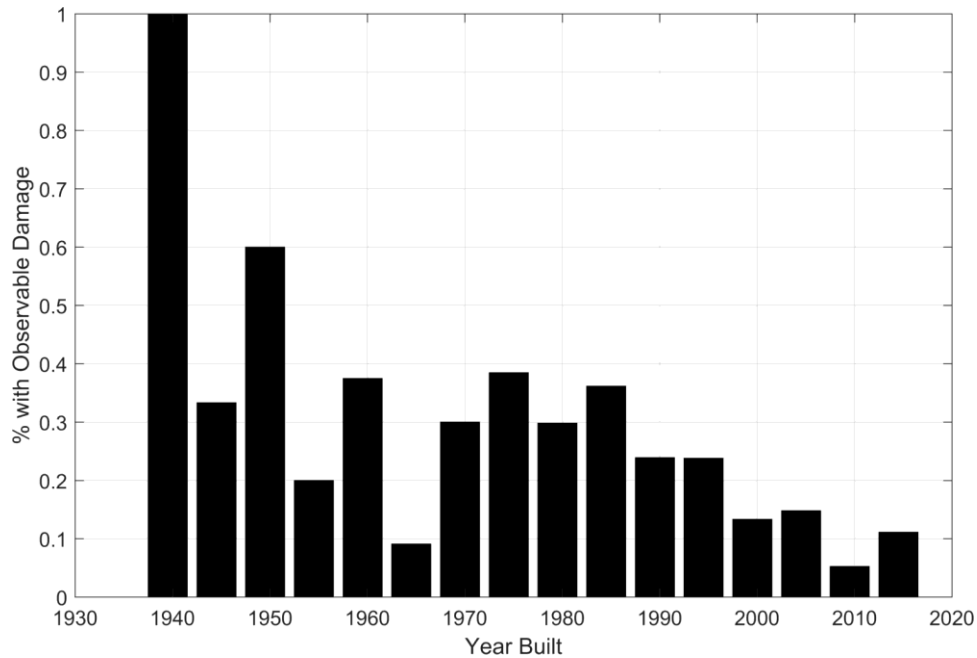
Figure 26: Percent of buildings with observable damage by year built in five year bins.
